Shoreline Changes in the Western Indian Ocean Region

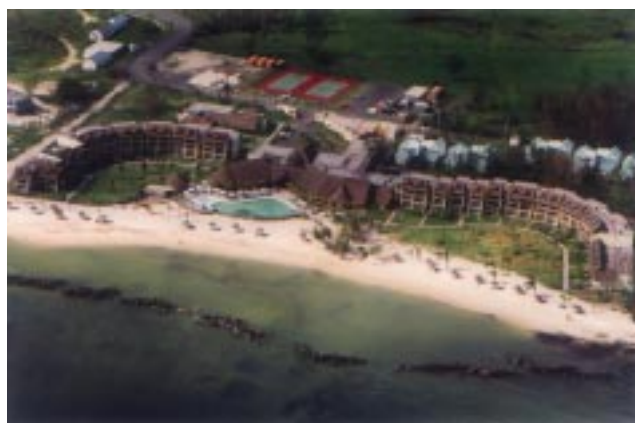
2

Fig. 2. Segmented breakwaters in front of the Hotel, near Wolmar, Mauritius (Mooloo and Luximon, 2003) **Fig. 3.** Gabion works at Cap Malheureux, north of Mauritius, to protect a cemetery (Mooloo and Luximon, 2003). **Fig. 4.** Rock armouring at Anse Kerlan, Seychelles (Quatre, 2003) **Fig. 5.** Some of the groyne constructed to protect Anse Kerlan (Quatre, 2003) **Fig. 6.** Planted vegetation on the coast of Anse Kerlan (Quatre, 2003). **Fig. 7.** Protection of the beach at Ile aux Sables, Mauritius using sand bags, used tyres and tree logs (@N. Soogon)

- A combination of at least two or three mitigation approaches has been found to be effective in controlling erosion. The hotel in the Wolmar area, Mauritius used rubble-filled Reno mattresses, beach nourishment and segmented rubble-mound offshore breakwater.
